IND.A.G.O. s.n.c.

2D-3D Electrical tomography on a waste site

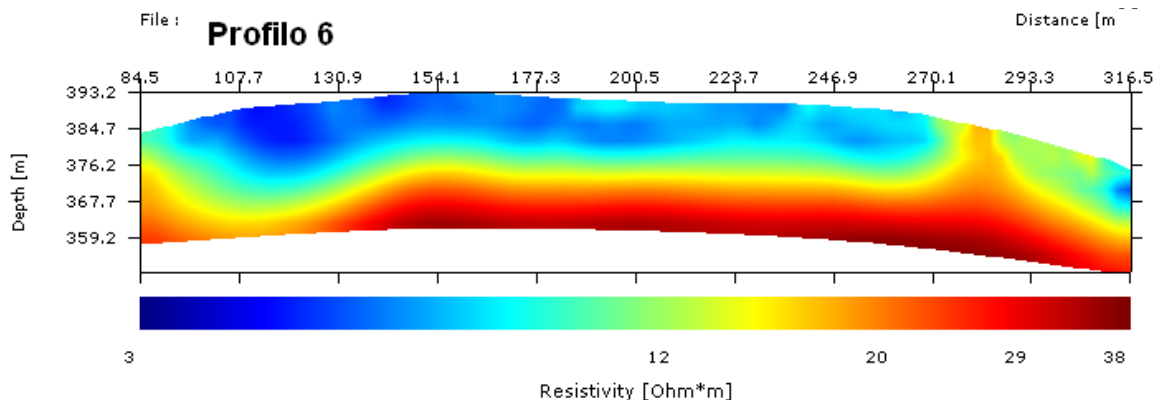
2d inverted section example:

An electrical tomography survey, commissioned by Daneco Impiantri srl, was carried out on Sant'Arcangelo Trimonte – Benevento province (Southern Italy) - municipal waste; the aim of the survey was to check the presence of leachate below HDPE membrane. ERT profiles were useful to detect contaminated areas. Some 2D/3D inversions are reported below.

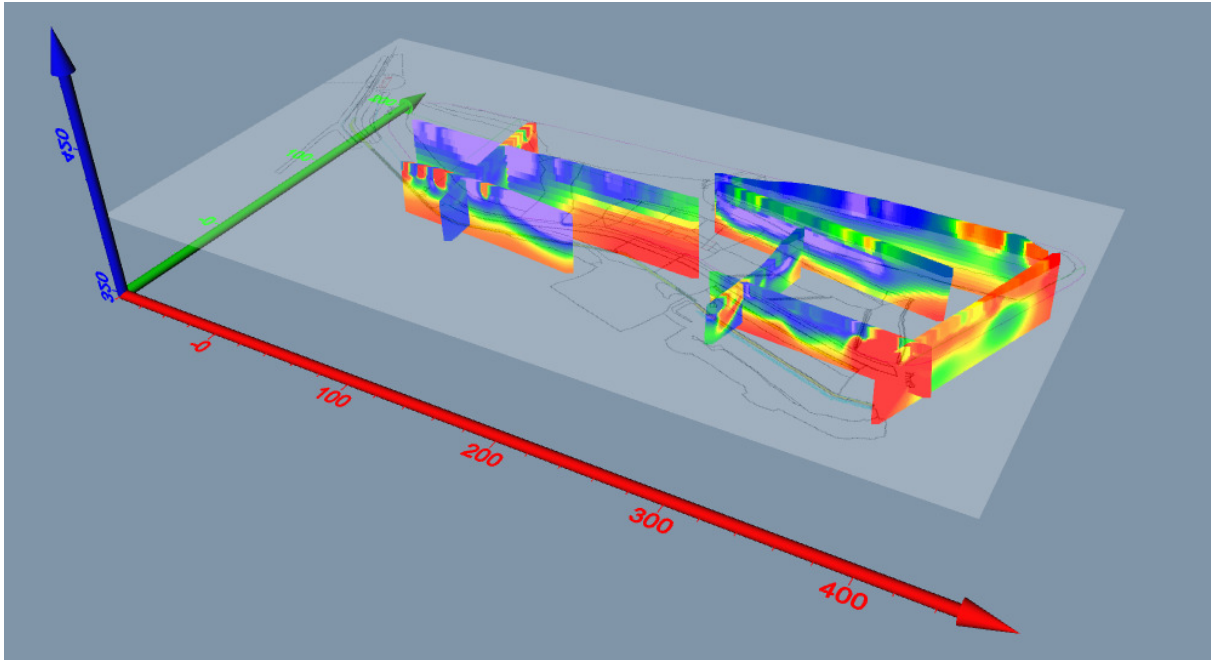
3d view:
